Manhole Inspection Summary

Manhole # S27E__072MH

Location Address: **109 E FREMONT AV**

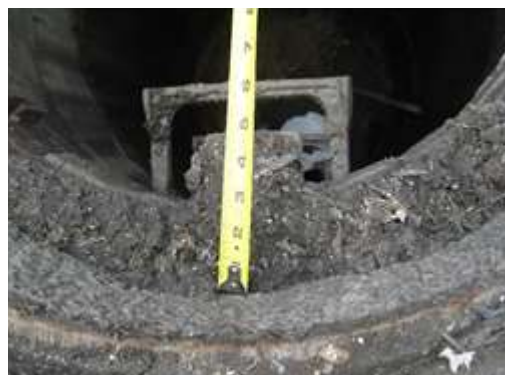
Defect 9

Frame Offset

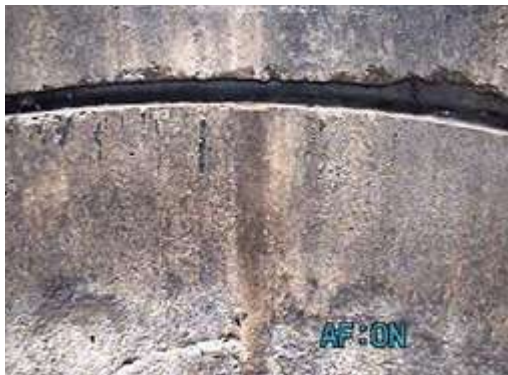
Defect 8

Infiltration: ☐ None ☒ **Joint** ☐ Cracks ☐ Mortar ☐ Roots ☐ Wall

corbel active infiltration

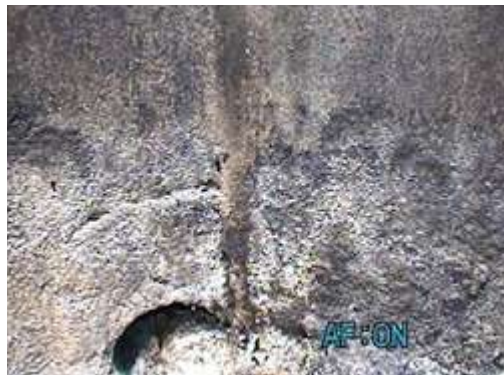
Defect 7

Condition: ☐ Sound ☐ Cracked ☐ Root Intrusion ☐ Loose Brick ☒ **Deteriorated**

Infiltration: ☐ None ☐ Joint ☐ Cracks ☐ Mortar ☐ Roots ☒ **Wall**

9 oclk area active infiltration and deterioration in barrel

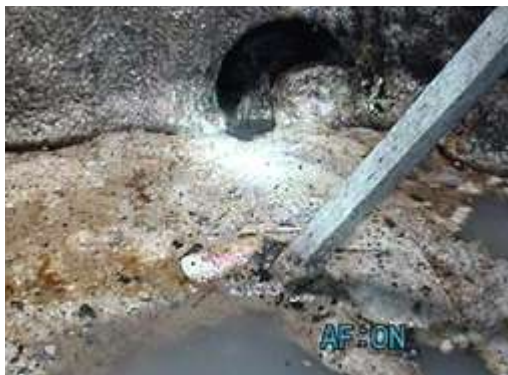
Defect 6

Condition: ☐ Sound ☐ Cracked ☐ Root Intrusion ☒ **Deteriorated** ☐ Leaks ☒ **Debris**

channel cond debris

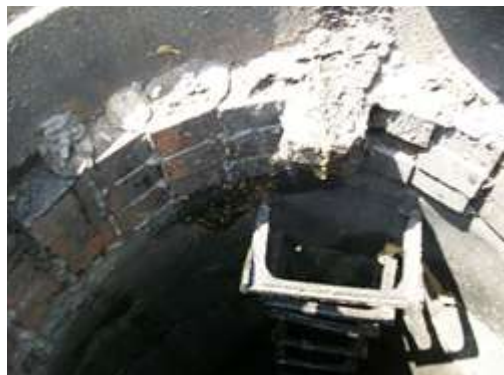
Defect 5

Infiltration: ☐ None ☒ **Joint** ☐ Cracks ☐ Mortar ☐ Roots ☐ Wall

INFILTRATION @ CORBEL/CHIMNEY JOINT

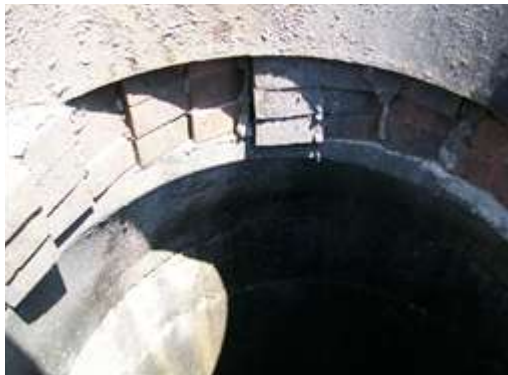
Defect 4

Condition: ☐ Sound ☐ Cracked ☐ Root Intrusion ☒ **Loose Brick** ☐ Deteriorated

LOOSE CHIMNEY BRICKS

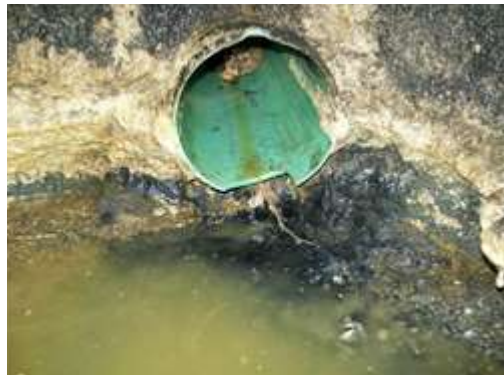
Defect 2

Comments **BENCH AND CHANNEL NEVER INSTALLED - GAP BELOW PIPES AND BOTTOM HAS NO FLOW DIRECTION; VACTORED OUT SEWAGE AND REMOVED BLOCKAGE BY FLUSHING LINE TO DOWNSTREAM MANHOLE**

CODED DETERIORATED CHANNEL;
NO CHANNEL OR BENCH WAS
INSTALLED - GAP OF 2.5 INCHES

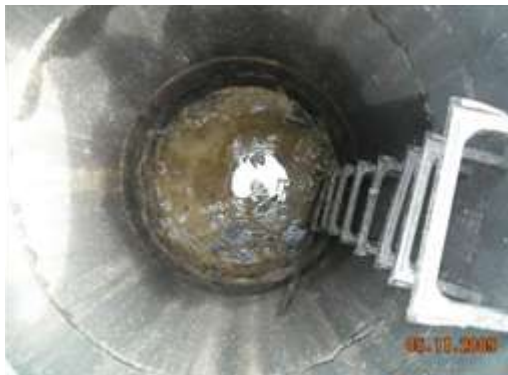
Defect 1

Surcharge ☒ **Evidence Of Surcharge** Depth: **3** (ft.) ☐ Active Surcharge Present

PRIOR ACTIVE SURCHARGE

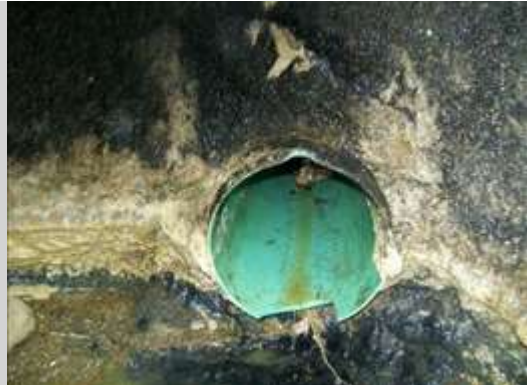
12 O'Clock Outflow

Pipe Height: **8.4** (in.) Rod and Bar (Angled)
Pipe Material: **PVC** ☐ Pipe Lined
Invert Depth: **10.38** (ft.) Flow Characteristics: **Slow**
Deposits: ☐ None ☐ Mud ☐ Sludge ☐ Debris ☒ **Grease**
Silt Depth: **1** (in.) Deposits Extent: **Light**
Infiltration: **None** Pipe Seal Cond: **Sound**

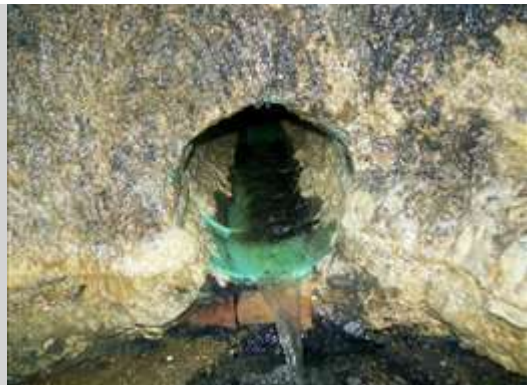
9 O'Clock Inflow

Pipe Height: **8.4** (in.) Rod and Bar (Angled)
Pipe Material: **PVC** ☐ Pipe Lined
Invert Depth: **10.28** (ft.) Flow Characteristics: **Slow**
Deposits: ☐ None ☐ Mud ☐ Sludge ☐ Debris ☒ **Grease**
Silt Depth: **1** (in.) Deposits Extent: **Light**
Infiltration: **None** Pipe Seal Cond: **Unknown**
